# Improve the Reliability of High Flux Reboilers

## A Treatment Approach for Dilution Steam Generator (DSG) Reboilers in Ethylene Plants

Karl Kolmetz<sup>1</sup>

Charles D. Nolidin<sup>2</sup>

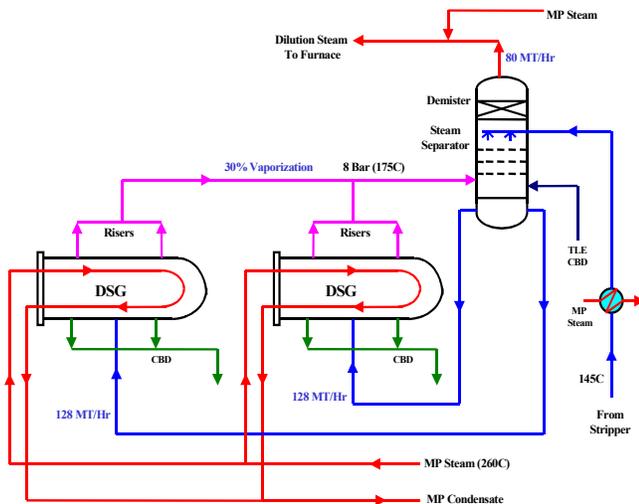
Figure 2: The Ethylene Unit Example's DSG Reboiler % Evaporation and Circulation Flow Rates.

In standard industrial boiler design, the % evaporation rate over water circulation rate is typically about 10% to ensure proper water circulation. Figure 2 shows the schematic of the Ethylene unit example's DSG system, water circulation and steam generation rates.

From the above review, it can be concluded that the previous amine treatment program apparently unable to provide satisfactory corrosion protection in DSG reboiler designed with high % evaporation rate. When operating under high % evaporation rate, the even water circulation in the entire horizontal reboiler can be compromised. As a result, pockets of steam/water separation will develop in the upper section of the reboiler. The existence of water line at certain areas in the upper section of the reboiler during inspection at the Ethylene unit example is a testimony to steam/water pockets formation. In addition, high evaporation rate in combination with steam/water separation promote iron and hydrocarbon deposition. This creates potential for localized under-deposit organic acids concentration, which leads to low pH corrosion effect.

At the Ethylene unit example, currently two reboilers are in service with one on standby. With all three reboilers in service the % evaporation would be lower (theoretically 20% lower), and consequently will help to reduce the propensity to develop high heat fluxes on the reboilers' tubes.

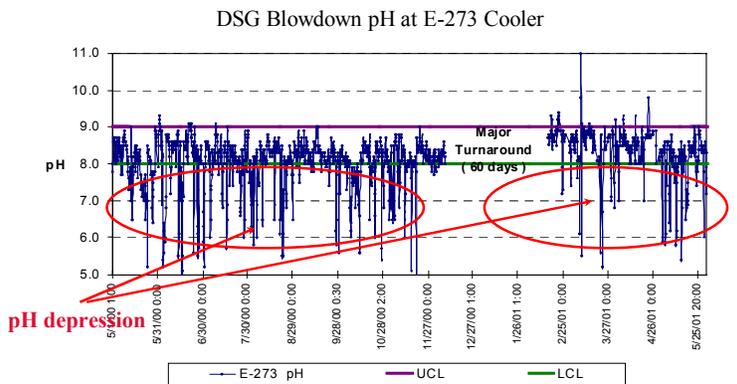
Chart 1: pH Trend at DSG Blowdown Before New Treatment Program at the Ethylene Unit Example.

Chart 1 shows the pH control trend for DSG reboilers blowdown at E-273 cooler before the new treatment program was implemented. The target pH control range was 8.0–9.0. The DSG blowdown reactive iron trend is shown in Chart 2. The average blowdown iron was 1.6 ppm.

About 10–40% of the time (6 pH data points per day), the reboiler water pH controls were less than 8.0. At pH below 8.0, the passive magnetite film, which protected the carbon steel, would be destroyed; and as such, significantly increased the general corrosion rate.

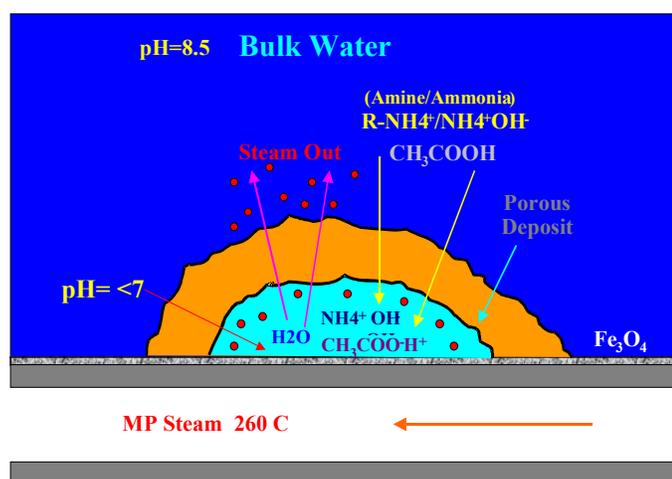
Figure 3: Under-deposit Concentration Cell–Low pH Corrosion.

section of the reboiler where bulk of the evaporation was expected to take place. The under-deposit corrosion developed as a result of the concentrated organic acids (mostly acetic) underneath the porous deposit as illustrate in Figure 3.

When bulk water at alkaline pH enters the porous deposit, compounded with the high % of evaporation rate taking places at the upper section of the bundle, the condition for setting up concentrated cells under the deposits (like a miniature boiler) prevails. The highly volatile ammonia will vaporize and travel with the steam, upsetting the base/acid ratio in the water phase. This can result in a localized low pH environment, which is highly corrosive towards magnetite and carbon steel; thus ultimately leads to tube leak.

Both of these conditions prevail when the % evaporation rate in the bulk water is high. This explains why the tube leaks are found only at the upper section of U-tubes bundle. In the case study discussed previously, the MP steam reboilers in Plant

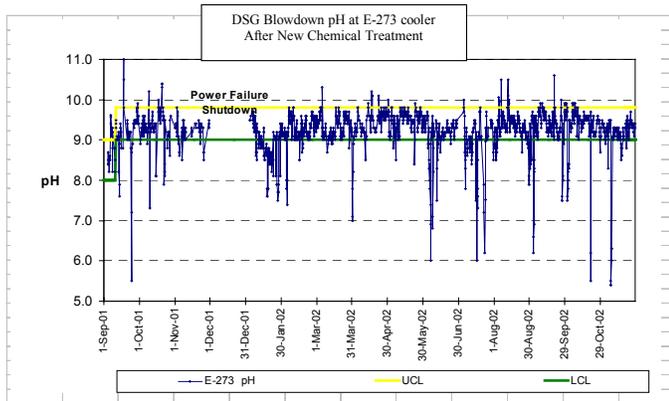
Chart 4: pH Trend at DSG Blowdown after the New Treatment Program at the Ethylene Unit Example.

As shown in Chart 4, the pH control is more stable in the range of 9.0 – 9.8. The pH depression below the target limit has been reduced.

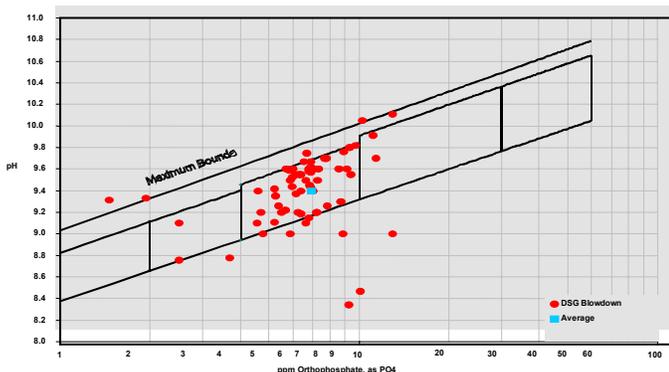
Chart 5: Coordinated pH/PO<sub>4</sub> Control in DSG Blowdown After New Treatment Program at the Ethylene Unit Example

Since the new DSG program is using the coordinated pH/PO<sub>4</sub> approach, the control of pH within 9.0 – 9.8 and PO<sub>4</sub> within 5 – 10 ppm is very essential. Chart 5 shows the Coordinated pH/PO<sub>4</sub> control for the new DSG chemical treatment program.

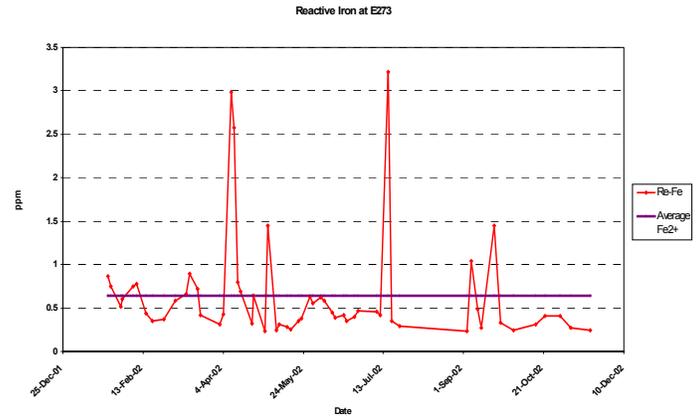
Chart 6: Iron loading of pH/PO<sub>4</sub> coordinated program.

The most important key performance indicator of the new program is the reduce corrosion and iron fouling rates by monitoring iron loading at the blowdown cooler, E-273, and the tubes failures history. As shown in Chart 6, the iron loading in DSG dropped from 1.6 ppm to below 0.6 ppm. This is more than 60% of iron reduction.
