Troubleshooting Practice in the Refinery

Prepared for presentation at the
AIChE Spring National Meeting

23-27 April 2001

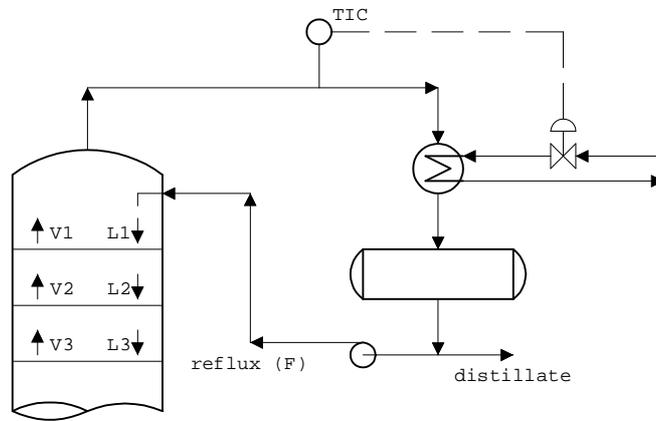
Figure 1
Subcooled reflux to tower

Referring to Figure 1, we see that L_F equals $L_2 - L_1$.

$$L_2 - L_1 = L_F = F \left(1 + \frac{h^* - h}{H_{eq} - h^*} \right)$$

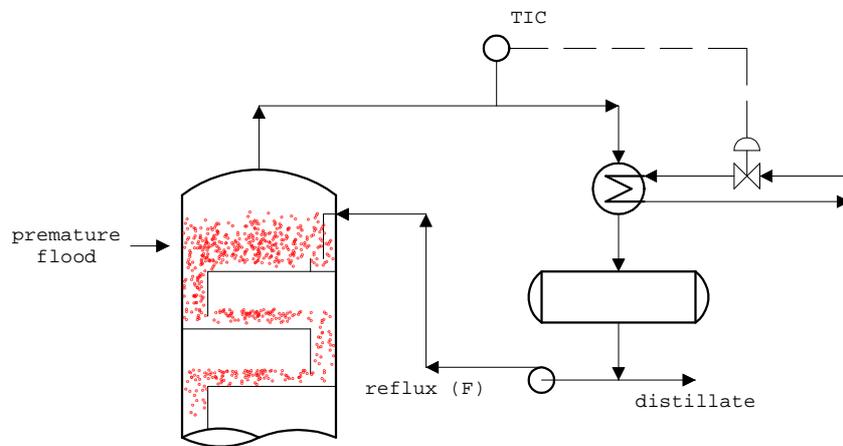
Figure 2
Subcooled reflux and premature flood

to raise the feed conditions to the bubble point temperature. The condensing vapor increases the liquid flow leaving the feed stage, flooding the column (Figure 2).

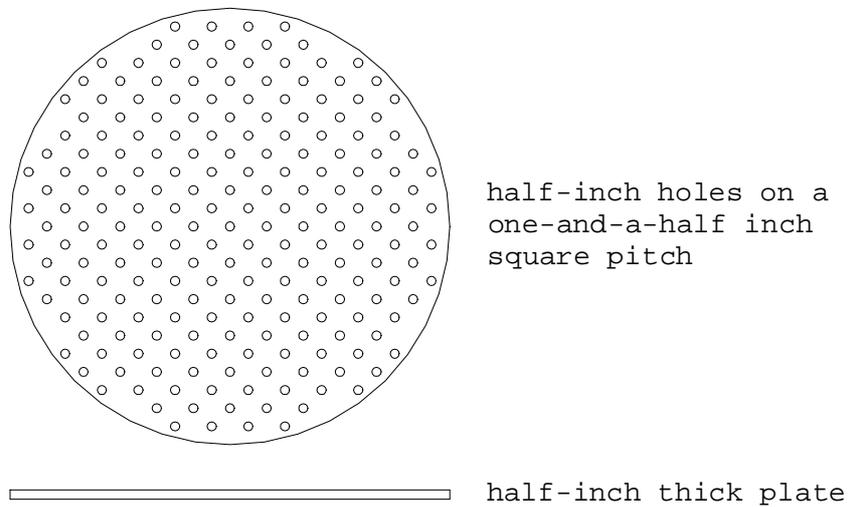
Figure 3 shows a perspective view of a liquid distributor that the author found installed in the column. Six years earlier, the plant had converted the stripper from a trayed column to a packed column. During the conversion, three homemade "supports" as shown in Figure 3 were installed to support the packing beds. Figure 4 shows the support locations in the side stripper. No after-modification test was run to check the performance of the modified unit.

The homemade support installed has a major defect. It had insufficient open area for vapor flow (9.2%). In a packing support plate, vapor flowing up and liquid flowing down have to share the same openings. For the liquid to flow down, the liquid height above the support plate has to overcome the pressure drop of the rising vapor. A small open area gives a high-pressure drop. The result was a cyclic operation where liquid stacked up above the distributor plate until enough liquid head was available to force the liquid down against the force of the rising vapor. Once liquid flowed, it dropped down the tower in a slug. This drained the liquid level above the support plate and started the entire cycle again. The liquid slugging showed up as a product viscosity variation.

Home-made support plate

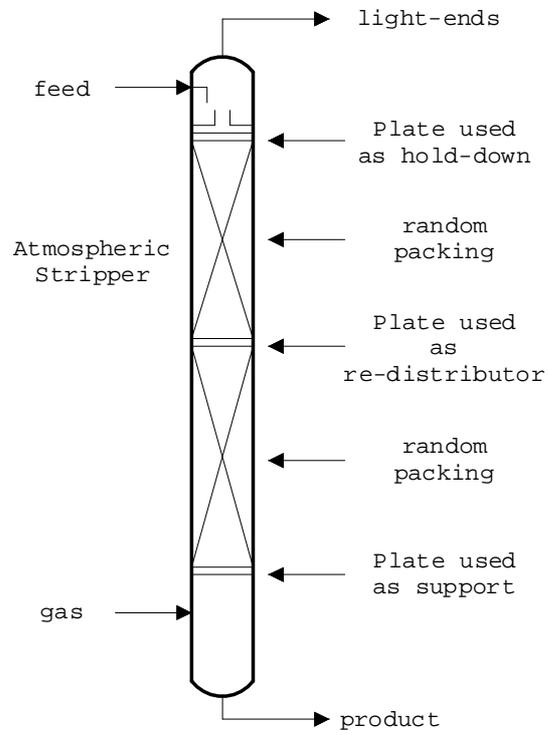
Figure 4
Stripper elevation schematic

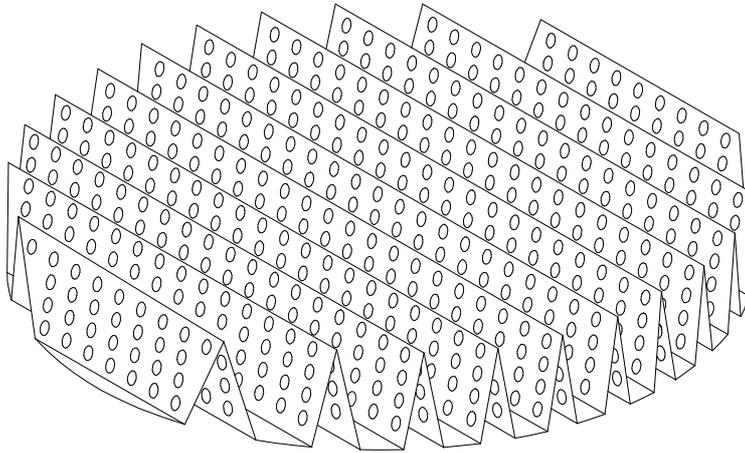
After finding the problem, a proper support plate was installed. Figure 5 shows the correctly designed support plate. A large open area through the support mesh gives low-pressure drop. An external ring around the edge (not shown) gives overall mechanical strength. After installation of the new support plates, the stripper worked correctly with close to zero viscosity variation.

Figure 5
Random packing support

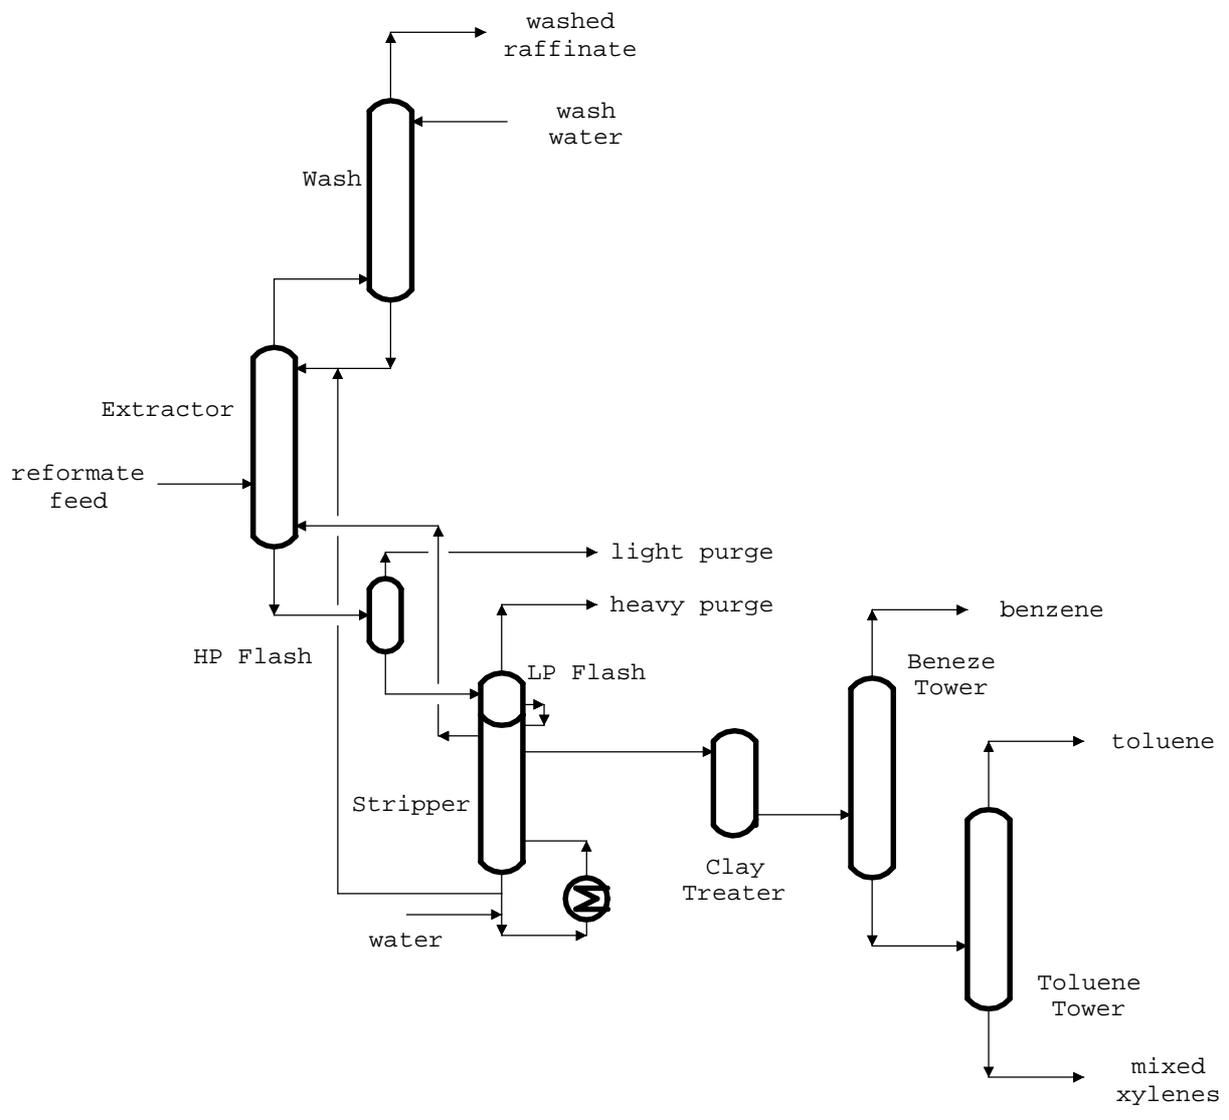
In a debottlenecking study of a Texas BTX unit, the stripper tower was determined to be the unit limit. The unit was built in the 1960's and had undergone several previous revamps to increase capacity. The unit included a liquid-liquid extractor, flash drum, stripper tower, raffinate water wash tower, aromatics clay treater and three aromatic distillation towers (Figure 6).

Figure 6
Aromatics Unit

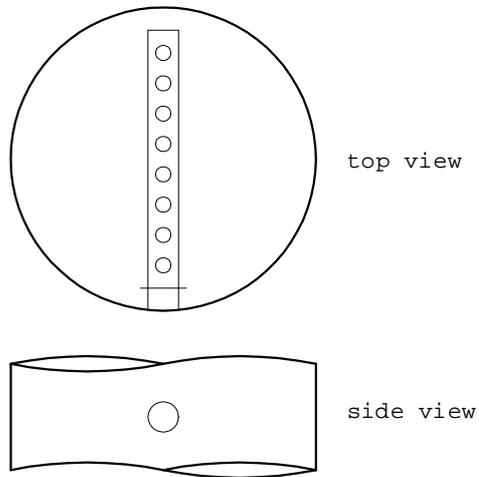
However, a problem arose when the unit was commissioned. The aromatic vapor sidecut now contained a much higher amount of solvent. Independent review at this point discovered the causes of the problem. The valves did not have a positive liquid seal and they weeped slightly, letting some solvent drop into the vapor draw header (Figure 7).

Figure 7
Unshrouded vapor side draw

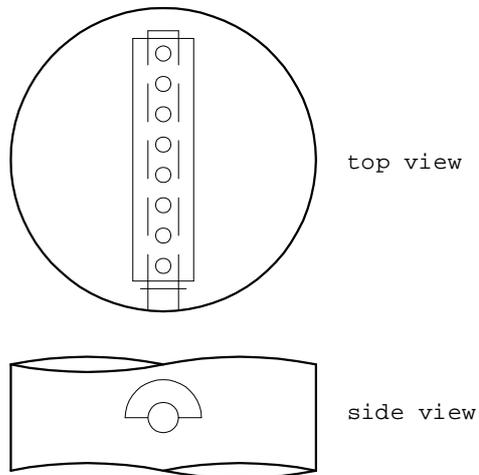
Correct vapor draw design takes into account possible leakage [4]. Vapor product draws should include shrouds over the vapor inlet ports to prevent liquid entrainment (Figure 8).

Figure 8
Shrouded vapor side draw

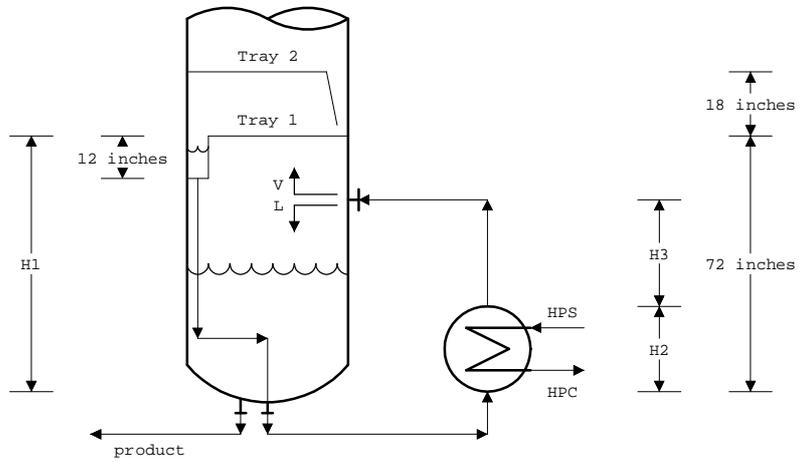
A petrochemical column was revamped with new trays. The column was a high-pressure service column (greater than 100 psig, 690 kpag). The column used a once-through thermosiphon reboiler for column boil-up. Before the revamp, the existing column arrangement had a feed pipe inside the column coming from a sump through the boot and then out the tower bottom to the reboiler feed line (Figure 9).

A once-through thermosiphon reboiler is classified as a natural circulation reboiler. Natural circulation is achieved by drawing liquid from the bottom tray and circulating it directly to the reboiler. The stream that returns to the column is partially vaporized. The net return liquid is recovered as bottom product (Figure 9) [5].

Figure 9
Once-through thermosiphon arrangement, before revamp

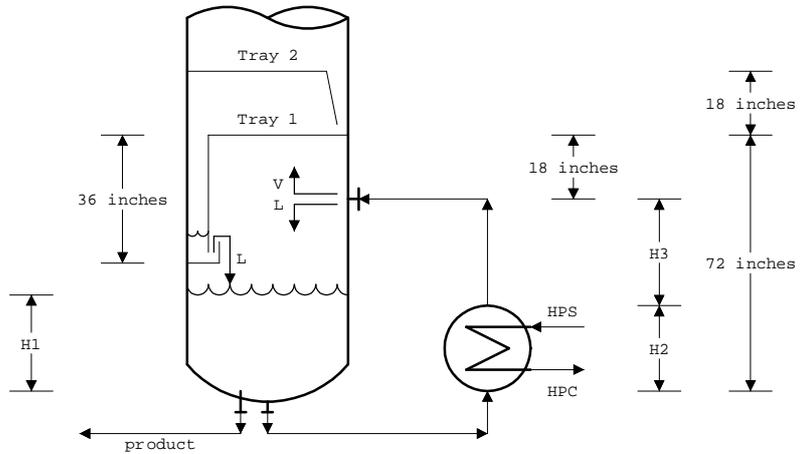
After the revamp, the column was started up and lined out. The column did not work. The problem was determined to be insufficient boil-up. This was found through analysis of field data and comparison of simulation work done before the column was revamped. After reviewing the revamp design of the column and inspection records, it was determined that the internal pipe feeding the reboiler and the tray sump had been removed. The liquid level driving flow through the reboiler was substantially reduced, thereby creating flow instability problems in the reboiler loop (Figure 10).

In order to increase the amount of liquid flow the liquid driving head must increase. The hydrostatic pressure difference between H1 and H3 has to be decreased (Figure 10). As the liquid driving head increases, the circulation rate increases, lengthening the nucleate boiling zone and reducing the mist flow zone. As this occurs the performance of the reboiler improves.

Figure 10
Recirculating thermosiphon arrangement, after revamp

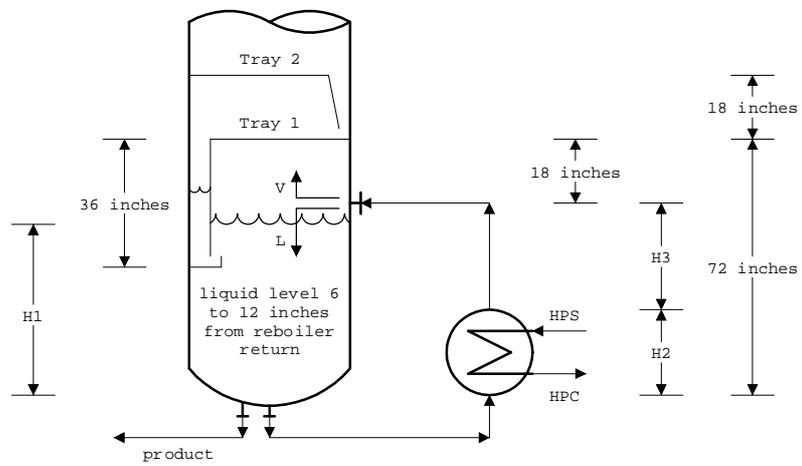
Figure 11
 Recirculating thermosiphon arrangement, after fix:
 sump modified and liquid operating level raised

One option to repair the column was to redesign the bottom tray and reinstall the internal down pipe to feed the reboiler. This would result in extensive amount of downtime due to the amount of welding that required to complete the repair. Another option was to raise the liquid level of the column to within six to 12 inches (15 to 30 cm) of the reboiler return nozzle (Figure 11). To prevent tray flooding, the seal pan required modifications. The effective control range for the bottoms liquid rate was narrow, but still possible. This option required very little downtime. The amount of hot work to be performed in the column was minimal. The repair decided upon was option two.

The modifications were made and the column was restarted. The seal pan was modified and the operating liquid level in the column increased to within six to 12 inches (15 to 30 cm) of the reboiler return nozzle (Figure 11). The column performed as expected. The column product was within specifications. There were no operational problems.

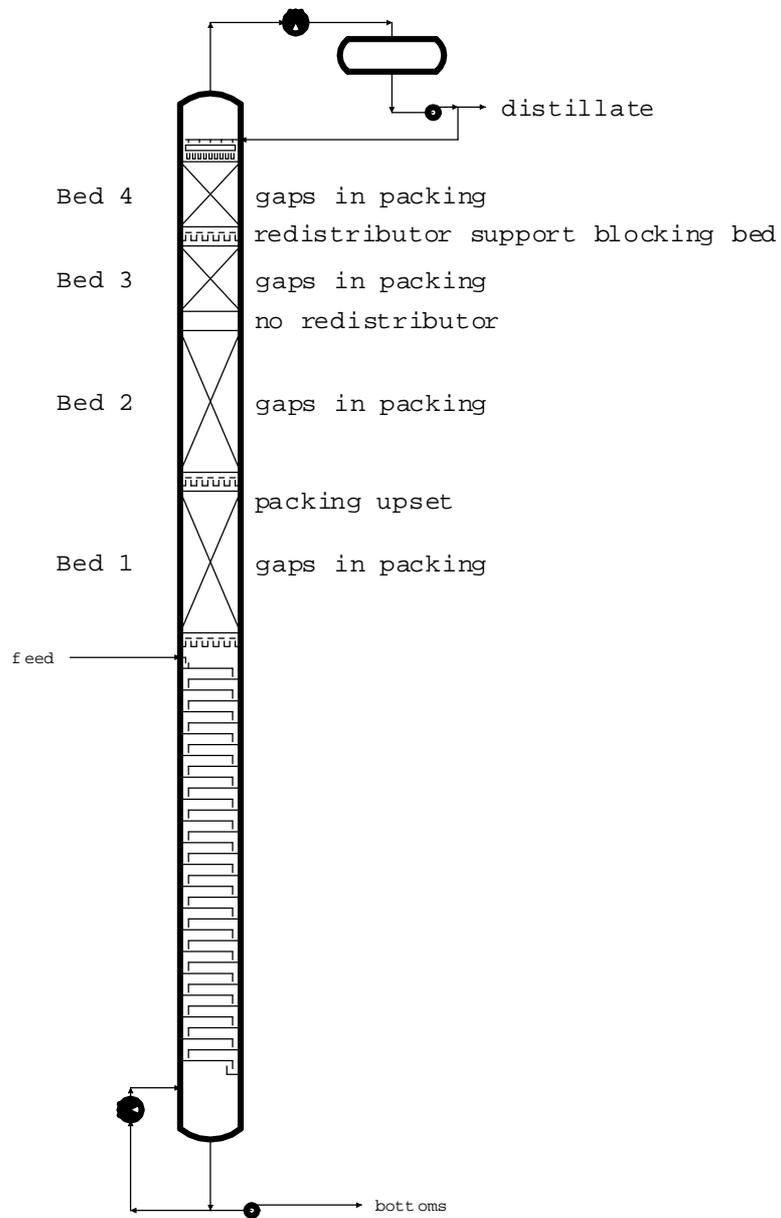
During the shutdown, maintenance personnel inspected ED (Figure 12) and stripper towers. In the ED tower packing was found to be up to 1/2 inch (12.7 mm) from the circumference of the wall. The packing also contained up to 1/2 inch (12.7 mm) openings in the middle of the bed. This can lead to channeling down the wall or through the openings in the middle of the bed with a loss in packing efficiency.

On the top of the third bed, inspection showed that the distributor was supported by 4x8 inch (10x20 cm) plates on top of the packing. The plates covered 8% of the packing. The bed would have had a higher capacity if the distributor was supported without the plates.

The bottom of the third bed did not have a liquid collector or redistributor. Liquid was allowed to freely rain down on the fourth bed. A liquid collector and redistributor has two functions. First is to collect the liquid and route it to the next tray. The second is to evenly distribute the vapor across the upper section.

Below the chimney tray above the second bed, the packing did not have a hold down grid. The packing appeared to be upset under the chimney tray.

Figure 12
Inspection results on extractive distillation tower

Further work is underway to implement solutions to the problems found by the maintenance department. These repairs will be made during the next unit shutdown.

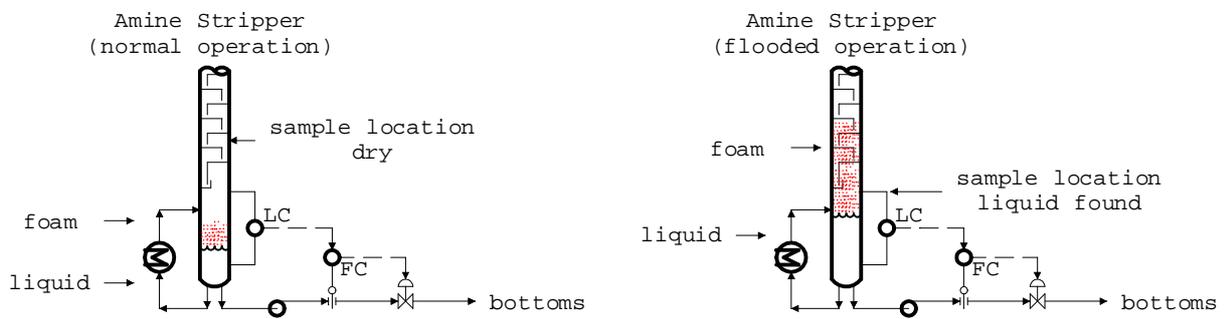
Field investigation eventually located a problem with the bottoms level control system. Taking a sample from the upper level tap during operation showed liquid in the sample, even though only vapor should be at this vessel elevation (Figure 13). Manually changing bottoms rates by large percentages showed no change in bottoms level. When foam fills the distance between a DP cell's pressure taps, the DP cell measures the liquid density, not the level in the vessel.

Figure 13
Flooding and liquid samples

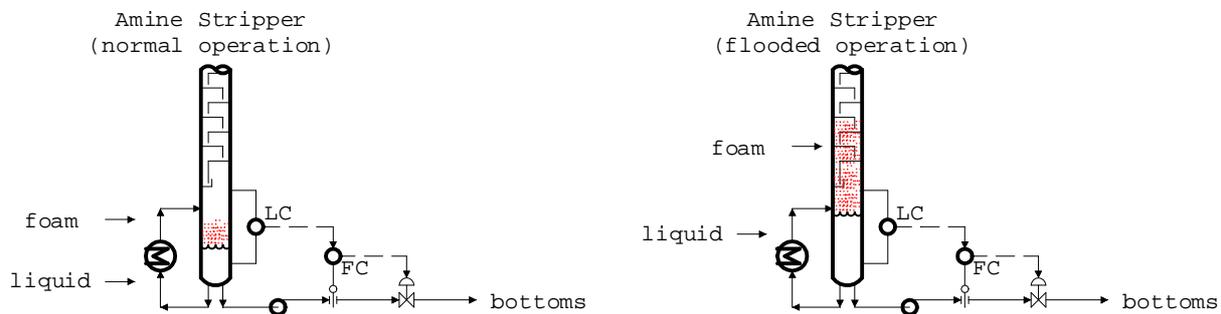
Figure 14
Flooded amine stripper operation

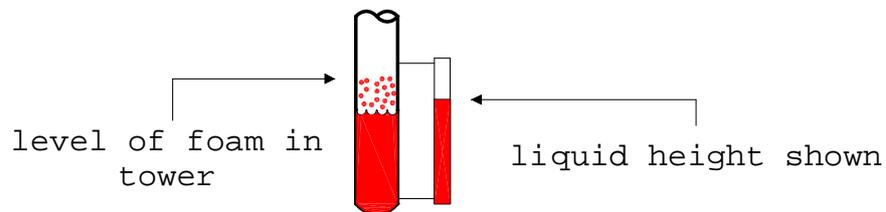
Amine units commonly suffer from foam formation in the tower boot. Differential pressure (DP) cells used to measure the bottoms liquid level convert a differential pressure into a liquid level based on an assumed boot liquid density. An incorrect density assumption can easily flood towers in this service (Figure 14). Contamination of system amine inventory during the shutdown was the suspected source of the foaming problem.

Figure 15
Foam and false liquid levels

Foam control chemistry was changed and stringent monitoring of amine system contaminants started. As a short-term fix, the level in the boot was deliberately kept at low indicated values to reduce the possibility of foam entrainment onto the trays.

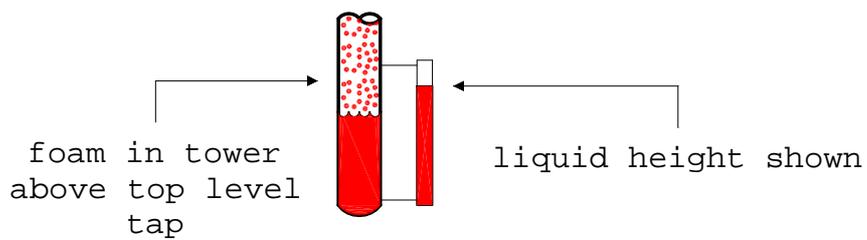
Once foam rises above the upper level tap for the DP cell (Figure 16), then the DP cell (or sight-glass) only shows average density inside the column, not liquid level.

Figure 16
Foam and complete filled tower
