**BTX Extractive Distillation Capacity
Increased by Enhanced Packing Distributors**

AIChE 2002 Spring Meeting
New Orleans, Louisiana, USA
10-14 March 2002

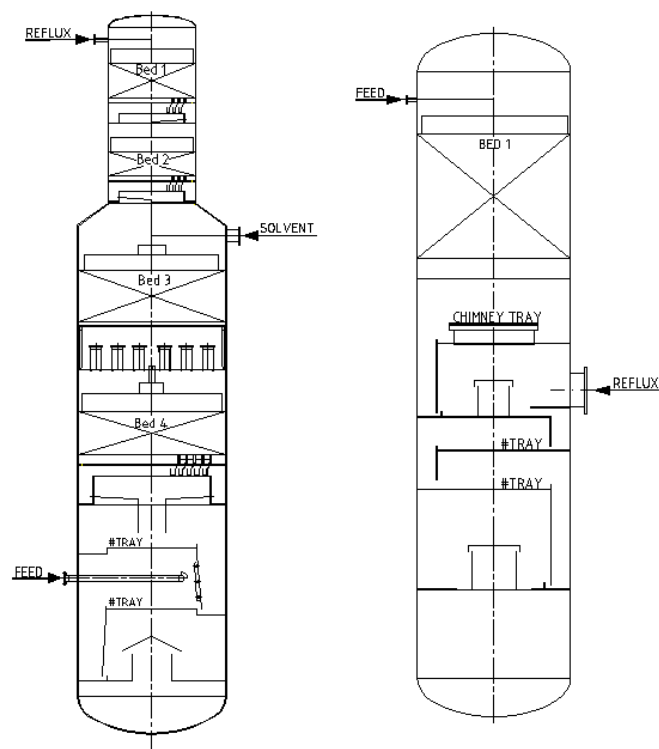
ED Column

Stripper Column

A grass roots extractive distillation BTX unit was commissioned in January 2000. The unit consisted of a Reactor Pretreatment Section, an Extractive Distillation (ED) Column, a Stripper Column, and a Benzene-Toluene Distillation Column. The ED Column has four structured packed sections in the rectifying section (top of the tower) and trays in the stripping section (bottom of the tower). The Stripper Column has one structured packed bed with one tray in the rectifying section and trays in the stripping section.

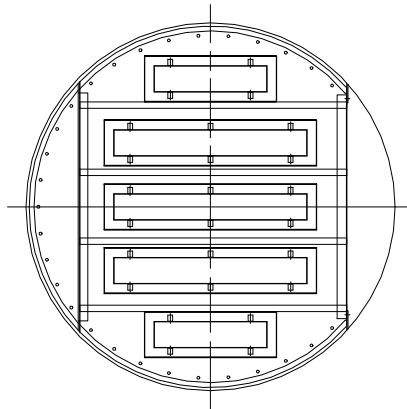
Schematic of new Chimney Tray

To reduce the solvent carry over, the top tray below the packed bed was converted to a chimney tray. A small amount of fractionation capacity was lost, but during the high load test the aromatics in the lean solvent had remained low. Chimney tray design seems straight forward, but several factors need to be considered in the design. The pressure drop of the chimney tray needs to be reviewed, and minimized if possible, as this tray does no actual fractionation. The vapor distribution needs to be reviewed and redistributed if necessary by the design of the chimney hats.

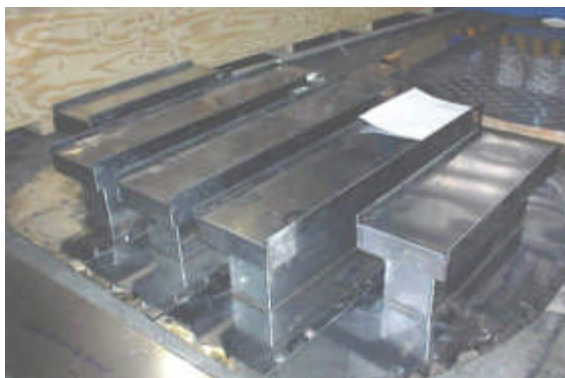
Picture of new Chimney Tray

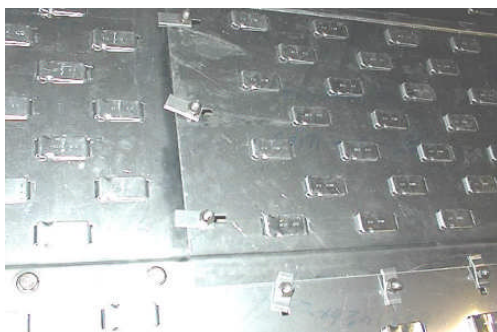
Picture of new Sulzer BDH smaller valve trays

The remaining Stripper Column trays were upgraded to the Z-Bar style with small valves to match the ED Column trays. They were rated to 140% of design. One negative of raising tower tray rates is the column down turn, or minimum rates. By increasing the design rating to 140%, the new effective column minimum-operating rate was raised.
